**Flood Control Project Maintenance  
Levee Inspections**  
**LMA District Cover Sheet**  
**Spring 2018 Levee Inspection Results**

**Reclamation District No. 2104 Peters Pocket Tract**

**Levee Inspection Report By Mile - Spring 2018**

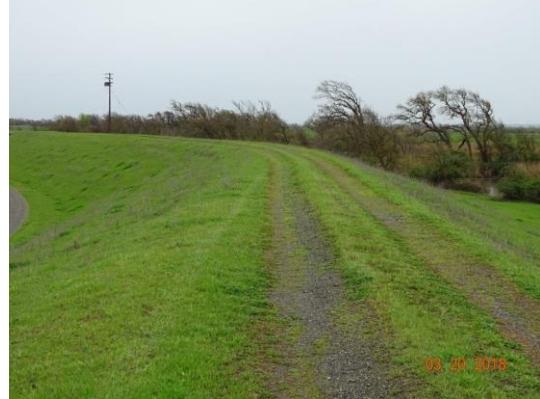
Photo 1 of 1 : SP\_2018\_RD2104\_249\_18\_20180321\_00037.jpg

LM Start	0.02	Rating **	A/W	Issue No.	18
LM End	1.45	Issue Type +	Ma	Location *	CR
Category	Earthen Levee			GPS Latitude/Longitude	
				Start	End
Item	Vegetation			38.308053 °	38.295298 °
				-121.758557 °	-121.741413 °
DWR ID	DWR_RD2104_01_f_2016_18				
Comment Code					
V9 : Keep the crown roadway free of vegetation.					
Inspector Comment

Spring 2018 - Crown road should be kept free of vegetation.

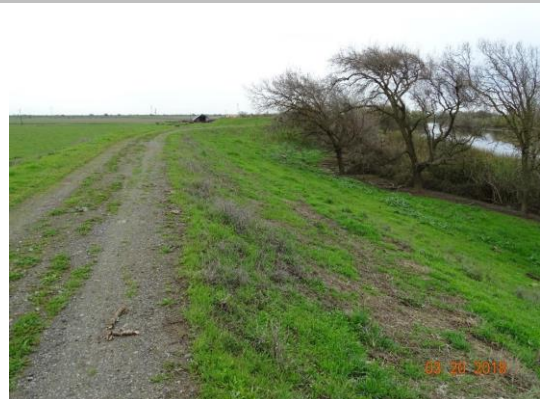
Photo 1 of 1 : SP\_2018\_RD2104\_249\_22\_20180321\_00038.jpg

LM Start	1.20	Rating **	A/W	Issue No.	22
LM End	1.20	Issue Type +	Ma	Location *	WS
Category	Earthen Levee			GPS Latitude/Longitude	
				Start	End
Item	Erosion / Bank Caving			38.296615 °	38.296615 °
				-121.745372 °	-121.745372 °
DWR ID	DWR_RD2104_01_f_2016_22				
Comment Code					
E2 : Schedule repair of erosion site prior to the next inspection.					
Inspector Comment					
Soil was added to restore waterside slope. Continue to monitor for erosion from cattle.

This previous erosion site should be monitored for future erosion from cattle.

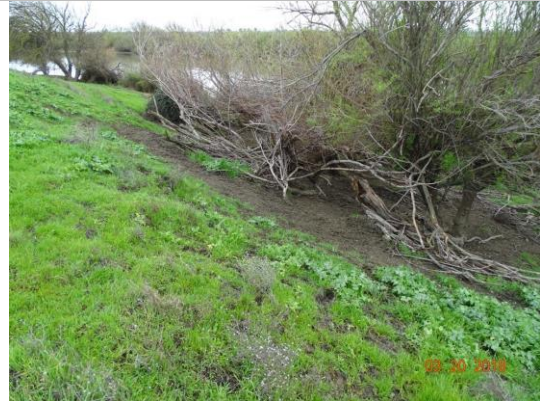
Photo 1 of 1 : SP\_2018\_RD2104\_249\_23\_20180321\_00039.jpg

LM Start	1.27	Rating **	M	Issue No.	23
LM End	1.27	Issue Type +	Ma	Location *	WS
Category	Earthen Levee			GPS Latitude/Longitude	
				Start	End
Item	Slope Stability			38.296182 °	38.296182 °
				-121.744318 °	-121.744318 °
DWR ID	DWR_RD2104_01_f_2016_23				
Comment Code					
S2 : Repair the levee slope damaged by foot traffic and prevent access where possible.					
Inspector Comment					
Repair the slope damaged by cows and trim up the tree limbs partially blocking the erosion site.

Spring 2018 - Trees should be trimmed and deadwood removed, and erosion from cattle repaired.

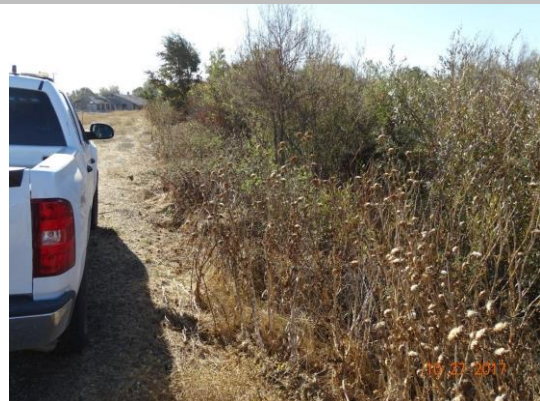
Photo 1 of 1 : SP\_2018\_RD2104\_249\_11\_20180305\_00001.jpg

LM Start	1.44	Rating **	U	Issue No.	11
LM End	1.48	Issue Type +	Ma	Location *	WS
Category	Earthen Levee			GPS Latitude/Longitude	
				Start	End
Item	Vegetation			38.295487 °	38.294947 °
				-121.741530 °	-121.741215 °
DWR ID	DWR_RD2104_01_f_2017_11				
Comment Code					
V2 : Remove the wild growth other than native grasses from the levee slopes.					
Inspector Comment

Remove wild growth to 20 feet from crown.

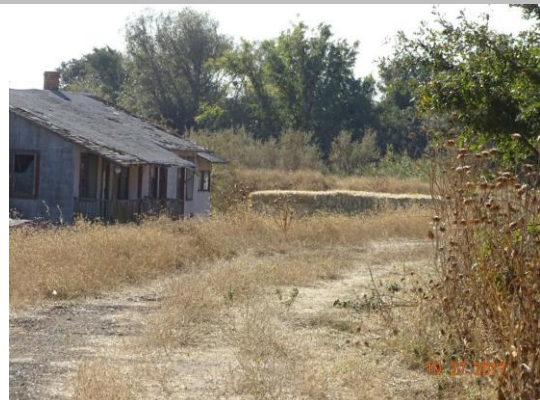
Photo 1 of 1 : SP\_2018\_RD2104\_249\_13\_20180305\_00002.jpg

LM Start	1.45	Rating **	M	Issue No.	13
LM End	4.00	Issue Type +	Ma	Location *	CR
Category	Earthen Levee			GPS Latitude/Longitude	
				Start	End
Item	Vegetation			38.295298 °	38.310680 °
				-121.741413 °	-121.736174 °
DWR ID	DWR_RD2104_01_f_2017_13				
Comment Code					
V9 : Keep the crown roadway free of vegetation.					
Inspector Comment

Crown vegetation should be reduced to facilitate inspection and access.

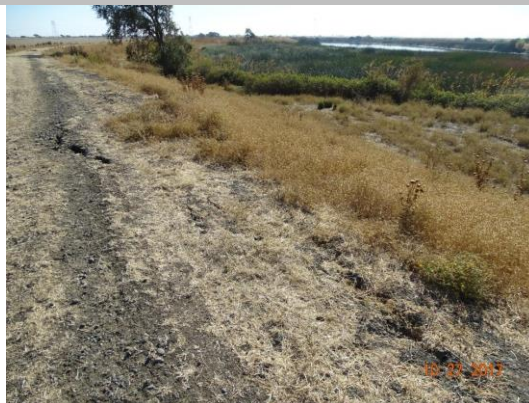
Photo 1 of 1 : SP\_2018\_RD2104\_249\_15\_20180305\_00003.jpg

LM Start	1.72	Rating **	A/W	Issue No.	15
LM End	1.72	Issue Type +	Ma	Location *	WS
Category	Earthen Levee			GPS Latitude/Longitude	
				Start	End
Item	Cracking			38.293465 °	38.293465 °
				-121.737778 °	-121.737778 °
DWR ID	DWR_RD2104_01_f_2017_15				
Comment Code					
CR1 : Monitor and have inspected by geotechnical engineer.					
Inspector Comment

Curved cracks in crown indicate possible slope instability on waterside slope. Cracks are 8 feet long x up to 6 inches wide x 3 feet deep. No other indications of slope instability observed. Levee toe is approx 40 feet from channel/slough edge.

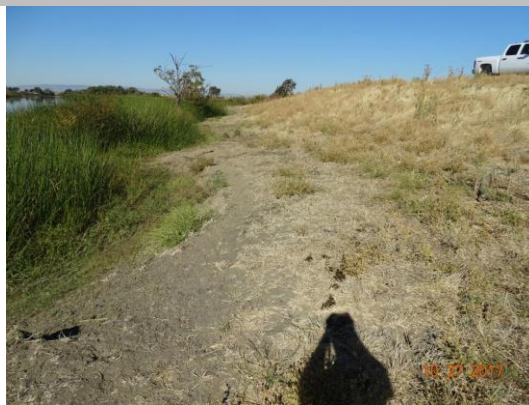
Photo 1 of 1 : SP\_2018\_RD2104\_249\_16\_20180305\_00004.jpg

LM Start	1.93	Rating **	M	Issue No.	16
LM End	1.94	Issue Type +	Ma	Location *	WS
Category	Earthen Levee			GPS Latitude/Longitude	
				Start	End
Item	Erosion / Bank Caving			38.292027 °	38.291947 °
				-121.734575 °	-121.734453 °
DWR ID	DWR_RD2104_01_s_2012_16				
Comment Code					
E1 : Note and monitor erosion site.					
Inspector Comment

Scalloped bank erosion along slough is approaching levee toe.

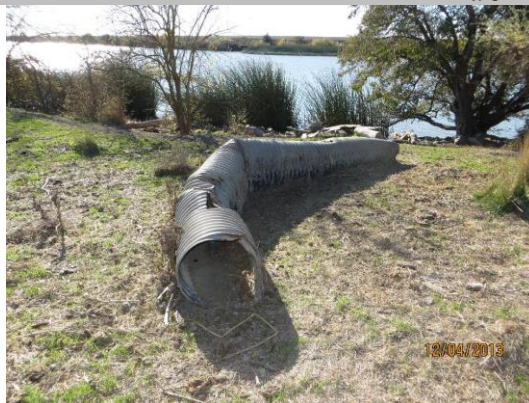
Photo 1 of 1 : UCIP\_SP\_2018\_41347\_45043.jpg

LM Start	2.40	Rating **	M	Issue No.	56
LM End	2.40	Issue Type +	En	Location *	
Category	Supplemental			GPS Latitude/Longitude	
				Start	End
Item	DWR UCIP Field Study			38.291579 °	38.291579 °
				-121.726159 °	-121.726159 °
DWR ID					
Comment Code					
Inspector Comment					
FS_ID:41347					
DS_ID:24726					
EP_NO: N/A					
Repair Type: Non-Urgent					
Crossing Status: Indicator Found					
UCIP Comments: 24-inch CMP debris on WS berm may indicate pipe was abandoned.					
FIELD_STRUCT_DESC: *ABANDONED* 24-inch corrugated metal drainage pipe through the levee, 18 feet below the crown. Flap gate on the waterside (WS) toe. [Additional Reference(s): USACE Sacramento O&M Manual 108, April 1964, (HLM 2.60)].					
FS Date: 12/4/2013

Pipe debris on WS berm.

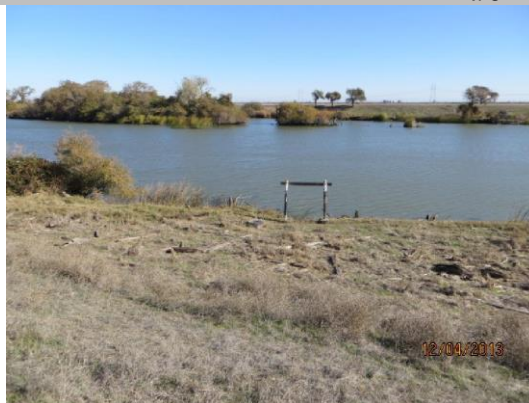
Photo 1 of 3 : UCIP\_SP\_2018\_41834\_45069.jpg

LM Start	3.04	Rating **	M	Issue No.	57
LM End	3.04	Issue Type +	En	Location *	
Category	Supplemental			GPS Latitude/Longitude	
				Start	End
Item	DWR UCIP Field Study			38.299447 °	38.299447 °
				-121.730444 °	-121.730444 °
DWR ID					
Comment Code					
Inspector Comment					
FS_ID:41834 DS_ID:24720 EP_NO: 14184 Repair Type: Non-Urgent Crossing Status: Found UCIP Comments: Signs in disrepair and need proper markings. FIELD_STRUCT_DESC: 6-inch steel gas line through the levee, 3 feet below the crown. Signs on both toes of the levee. FS Date: 12/4/2013

Sign on WS berm.

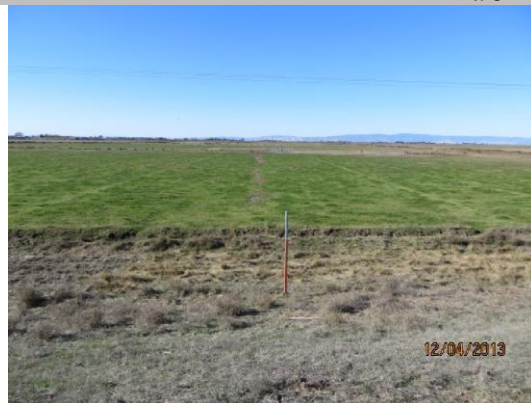
Photo 2 of 3 : UCIP\_SP\_2018\_41834\_45068.jpg

LM Start	3.04	Rating **	M	Issue No.	57 (cont)	
LM End	3.04	Issue Type +	En	Location *		
Category	Supplemental			GPS Latitude/Longitude		
				Start	End	
Item	DWR UCIP Field Study			38.299447 °	38.299447 °	
				-121.730444 °	-121.730444 °	
DWR ID						
Comment Code						
Inspector Comment						
FS_ID:41834 DS_ID:24720 EP_NO: 14184 Repair Type: Non-Urgent Crossing Status: Found UCIP Comments: Signs in disrepair and need proper markings. FIELD_STRUCT_DESC: 6-inch steel gas line through the levee, 3 feet below the crown. Signs on both toes of the levee. FS Date: 12/4/2013

Sign post on LS toe.

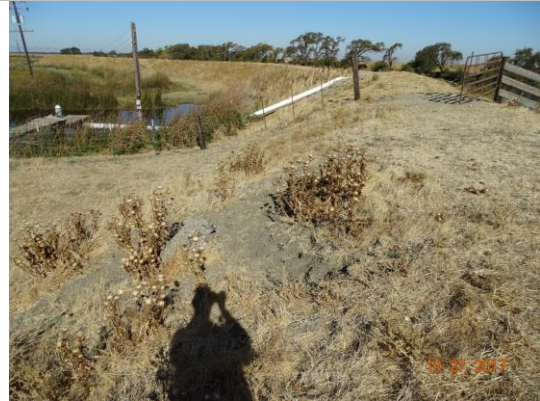
Photo 1 of 1 : SP\_2018\_RD2104\_249\_21\_20180305\_00007.jpg

LM Start	4.00	Rating **	M	Issue No.	21
LM End	4.00	Issue Type +	Ma	Location *	LS
Category	Earthen Levee			GPS Latitude/Longitude	
				Start	End
Item	Slope Stability			38.310672 °	38.310672 °
				-121.736155 °	-121.736155 °
DWR ID	DWR_RD2104_01_f_2017_21				
Comment Code					
S2 : Repair the levee slope damaged by foot traffic and prevent access where possible.					
Inspector Comment

Repair landside slope eroded by livestock, and prevent future erosion.

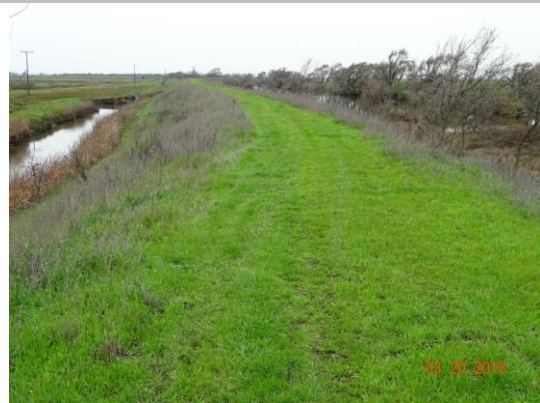
Photo 1 of 1 : SP\_2018\_RD2104\_249\_10\_20180321\_00040.jpg

LM Start	4.24	Rating **	M	Issue No.	10
LM End	4.72	Issue Type +	Ma	Location *	LS
Category	Earthen Levee			GPS Latitude/Longitude	
				Start	End
Item	Vegetation			38.313124 °	38.318437 °
				-121.739072 °	121.744572 °
DWR ID	DWR_RD2104_01_s_2018_10				
Comment Code					
V2 : Remove the wild growth other than native grasses from the levee slopes.					
Inspector Comment

Landside (left) vegetation should be managed to allow inspection and access to slope and toe.

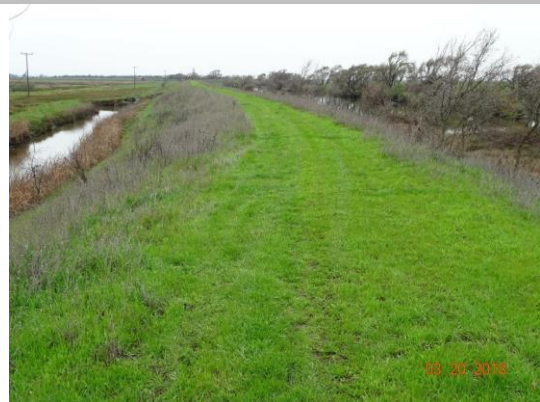
Photo 1 of 1 : SP\_2018\_RD2104\_249\_17\_20180321\_00041.jpg

LM Start	4.24	Rating **	M	Issue No.	17
LM End	4.72	Issue Type +	Ma	Location *	WS
Category	Earthen Levee			GPS Latitude/Longitude	
				Start	End
Item	Vegetation			38.313124 °	38.318437 °
				-121.739072 °	121.744572 °
DWR ID	DWR_RD2104_01_s_2018_17				
Comment Code					
V2 : Remove the wild growth other than native grasses from the levee slopes.					
Inspector Comment

Waterside (right) vegetation should be managed to 20 feet from crown to allow inspection and access.

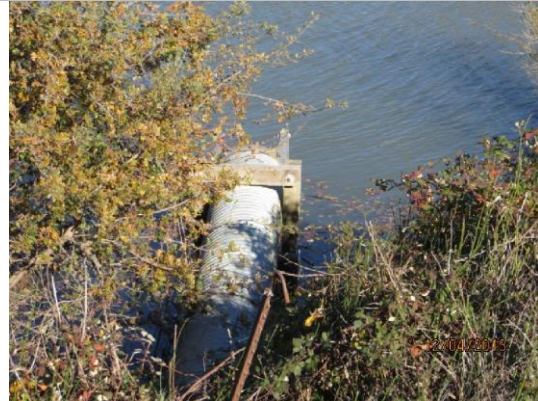
Photo 1 of 3 : UCIP\_SP\_2018\_51459\_45062.jpg

Item	DWR UCIP LMA Responsibility	38.313955 °	38.313955 °	-121.739930 °	-121.739930 °
		-121.739930 °	-121.739930 °		
DWR ID					
Comment Code					
Inspector Comment					
FS_ID:51459 DS_ID:24705 EP_NO: 10182 Repair Type: Non-Urgent Crossing Status: Found UCIP Comments: 12/06/2016 Crossing has been downgraded from "Urgent" to "Non-Urgent" no signs of leaks observed along pipe alignment (limited inspection on WS toe). According to LMA representative, this crossing was replaced 6 years ago (2010) at WS concrete apron. Recommend conducting internal inspection of pipe through the levee and LS to determine pipe integrity. (O. Magana - DWR UCIP)12/04/2013 Vegetation and soil buildup throughout pipe preventing flapgate from closing. Remove vegetation to allow gate to close properly. (W. Wylie - DWR UCIP) FIELD_STRUCT_DESC: 24-inch corrugated metal drainage pipe through the levee, 15 feet below the crown. 36-inch concrete standpipe on the landside (LS) toe. Flap gate on the waterside (WS) toe. Two corrugated metal cutoff walls installed. (24-inch pipe [HLM 4.65] authorized under Automatic Board Order (ABO) issued as Permit No. 10182, 1974 - Julia Trust Machado). [Additional Reference(s): DWR Levee Log, 2006. USACE Sacramento O&M Manual 108, April 1964, (HLM 4.65), Drawing No. 50-04-3379]. FS Date: 12/6/2016

CMP pipe and flapgate off WS toe.

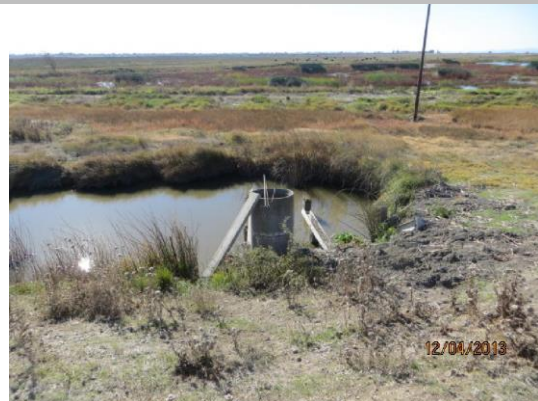
Photo 2 of 3 : UCIP\_SP\_2018\_51459\_45061.jpg

36-inch concrete riser on LS toe at channel.

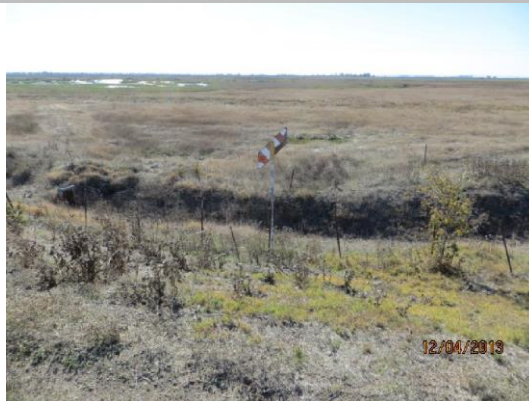
Photo 1 of 2 : UCIP\_SP\_2018\_25003\_45081.jpg

LM Start	4.65	Rating **	M	Issue No.	60
LM End	4.65	Issue Type +	En	Location *	
Category	Supplemental			GPS Latitude/Longitude	
				Start	End
Item	DWR UCIP Field Study			38.317941 °	38.317941 °
				-121.743503 °	-121.743503 °
DWR ID					
Comment Code					
Inspector Comment					
FS_ID:25003					
DS_ID:24704					
EP_NO: 10182					
Repair Type: Non-Urgent					
Crossing Status: Found					
UCIP Comments: Sign on WS toe needs repair.					
FIELD_STRUCT_DESC: 8-inch steel gas line through the levee, at the high elevation. Signs on both toes of the levee. (Automatic Board Order (ABO) issued as Permit No. 10182, 1974 - Julia Trust Machado).					
[Additional Reference(s): DWR Levee Log, 2006. USACE Sacramento O&M Manual 108, April 1964, Drawing No. 50-04-3379].					
FS Date: 12/4/2013

Gasline marker on LS toe.

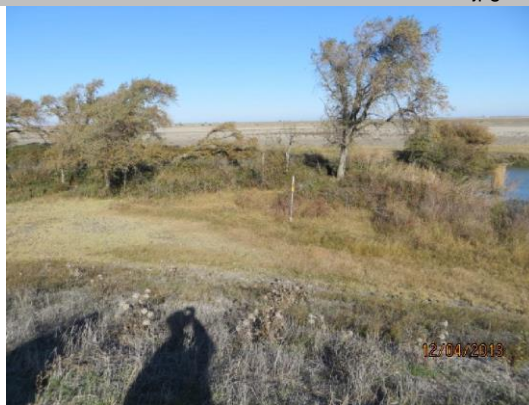
Photo 2 of 2 : UCIP\_SP\_2018\_25003\_45080.jpg

Sign pole on WS toe missing sign.

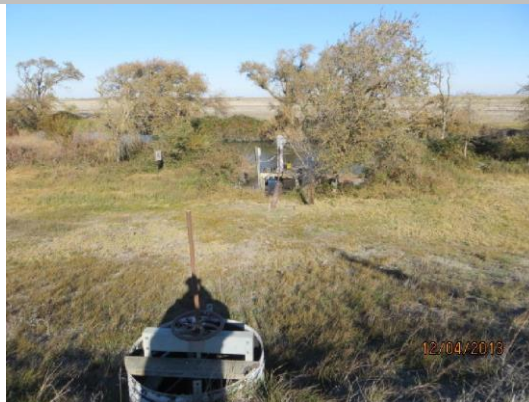
Photo 2 of 2 : UCIP\_SP\_2018\_25005\_45082.jpg

Slide gate in CMP riser on WS slope with pump on pier in background.

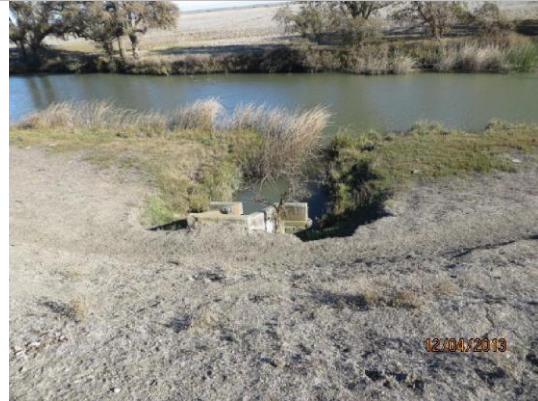
Photo 1 of 3 : UCIP\_SP\_2018\_51460\_45090.jpg

Comment Code					
Inspector Comment					
FS_ID:51460 DS_ID:24701 EP_NO: 10182 Repair Type: Urgent Crossing Status: Found UCIP Comments: 12/06/2016 same as last inspection--pipe remains "Urgent" CMP shows holes through wall and concrete headwall is undermined. Need to contact owner. Owner will need to work with the CVFPB to comply with Title 23. (O. Magana - DWR UCIP)12/04/2013 Footing under headwall on WS toe severely undermined. Pipe rusted heavily with holes at WS and may need replacement. (W. Wylie - DWR UCIP) FIELD_STRUCT_DESC: 24-inch corrugated metal drainage pipe through the levee, 13 feet below the crown. Two cutoff walls. Concrete U-shaped headwalls on both ends. Flap gate on the waterside (WS). (24-inch pipe [HLM 5.50] authorized under Automatic Board Order (ABO) issued as Permit No. 10182, 1974 - Julia Trust Machado). [Additional Reference(s): DWR Levee Log, 2006. USACE Sacramento O&M Manual 108, April 1964, (HLM 5.5), listed as a 12-inch pipe, Drawing No. 50-04-3379, listed as an 18-inch pipe]. FS Date: 12/6/2016

Concrete U-shaped headwall on WS toe. Note erosion scarp around headwall.

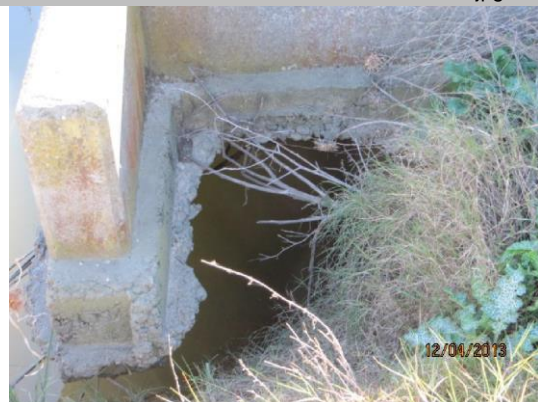
Photo 2 of 3 : UCIP\_SP\_2018\_51460\_45089.jpg

Headwall undermined on WS toe.

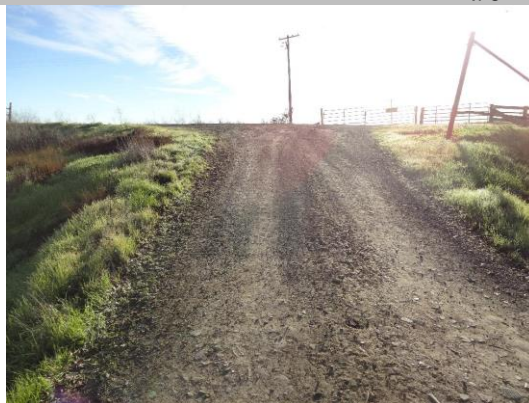
Photo 1 of 3 : UCIP\_SP\_2018\_51461\_76913.jpg

FS\_ID:51461  
DS\_ID:24699  
EP\_NO: 10184  
Repair Type: Urgent  
Crossing Status: Indicator Found  
UCIP Comments: 12/06/2016 No indicators were found. According to LMA representative, the gas line has been abandoned and markers have been removed about 10-15 years ago. Solano County was performing work on the LS toe approximately 700 feet from LS toe and according to their underground service alert (USA) survey completed for their construction site no PGE line was identified. Need to contact owner to determine abandoned as-builts for 8-inch line. (O. Magana - DWR UCIP)12/04/2013 Pump station visible to north on LS toe. Good indicator of location. Need PG+E to mark pipe location. (W. Wylie - DWR UCIP)  
FIELD\_STRUCT\_DESC: 8-inch iron gas line through the levee, 2 feet below the crown. (8-inch gas line authorized under Automatic Board Order (ABO) issued as Permit No. 10184, 1974 - Pacific Gas and Electric Company [PG&E]. 8-inch gas line first referenced in the USACE O&M as-built drawings from 1956). [Additional Reference(s): DWR Levee Log, 2006. USACE Sacramento O&M Manual 108, April 1964, Drawing No. 50-04-3379A, Sheet 3379/2, Page 2 of 7, (Station 82+30)].

No signs present at ramp to enter RD2104.

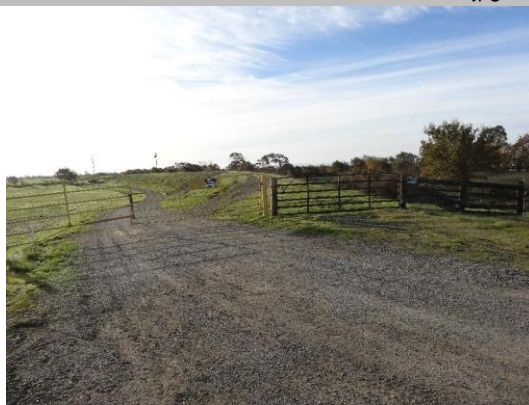
Photo 2 of 3 : UCIP\_SP\_2018\_51461\_76914.jpg

No signs present of gas line.

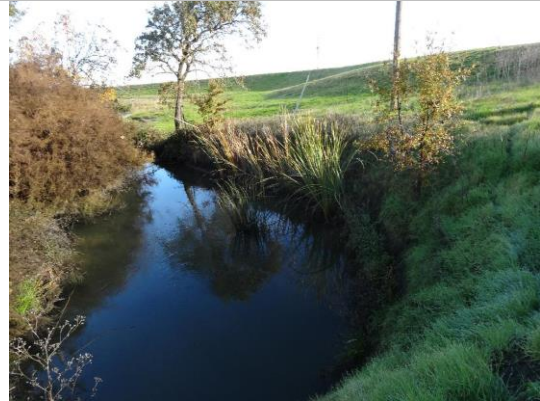
Photo 3 of 3 : UCIP\_SP\_2018\_51461\_76915.jpg

Comment Code						
Inspector Comment						
FS_ID:51461 DS_ID:24699 EP_NO: 10184 Repair Type: Urgent Crossing Status: Indicator Found UCIP Comments: 12/06/2016 No indicators were found. According to LMA representative, the gas line has been abandoned and markers have been removed about 10-15 years ago. Solano County was performing work on the LS toe approximately 700 feet from LS toe and according to their underground service alert (USA) survey completed for their construction site no PGE line was identified. Need to contact owner to determine abandoned as-builts for 8-inch line. (O. Magana - DWR UCIP)12/04/2013 Pump station visible to north on LS toe. Good indicator of location. Need PG+E to mark pipe location. (W. Wylie - DWR UCIP) FIELD_STRUCT_DESC: 8-inch iron gas line through the levee, 2 feet below the crown. (8-inch gas line authorized under Automatic Board Order (ABO) issued as Permit No. 10184, 1974 - Pacific Gas and Electric Company [PG&E]. 8-inch gas line first referenced in the USACE O&M as-built drawings from 1956). [Additional Reference(s): DWR Levee Log, 2006. USACE Sacramento O&M Manual 108, April 1964, Drawing No. 50-04-3379A, Sheet 3379/2, Page 2 of 7, (Station 82+30)]. FS Date: 12/6/2016

Photo of where the line is estimated to cross on LS.
